Assessment of slope instability and its impact on land status: a case study from Central Himalaya, India

Abstract: Tectonic instability, geological sensitivity along with human intrusion in Himalaya has greatly exacerbated the occurrence of hazardous situation. Dynamics of slope instability have been evaluated under three processes leading to geomorphic instability, viz. i. erosion ii. mass wasting and iii. anthropogenic. Their causative factors have been identified under Ghuniyoli Gad watershed. The measurement of the intensity, magnitude and nature of instability factors were done within the units of 1 km² under 21 units of watershed. Each unit was evaluated in terms of type, extent and corresponding degree of instability along with their potential assessment. The stage of erosion reveals that Ghuniyoli Gad watershed experiences instability. Maximum units fall under instability of degree 1 and degree 2 (38% and 38%) while minimum units belong to instability of degree 4 (4.76%). The instability of degree 3 contributes only about 19.04%. Appropriate mitigation measures to overcome hazardous calamities are needed to be introduced therein.

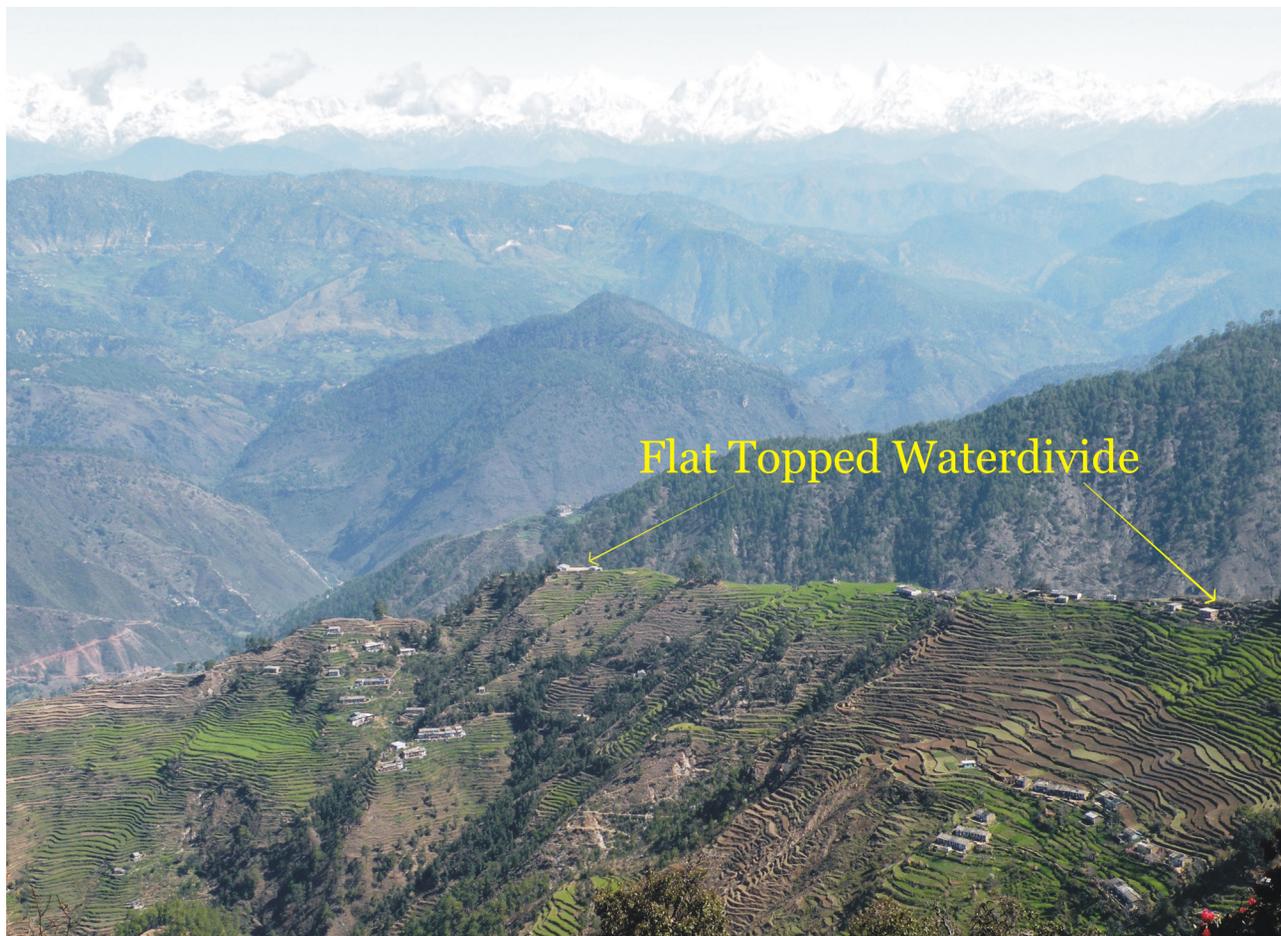
Fig. 2. Sharp ridges and wide valleys of the study area. Location of settlement along flat topped waterdivide in Thala Village

Wide valleys, with slopes developed up to sharp spurs and extended ridges are characteristic landforms in the area (Fig. 2). The altitude ranges between 840 m to 2,346 m a.s.l. and 34.14% of the area is located above 2,100 m a.s.l. while only 6.95%

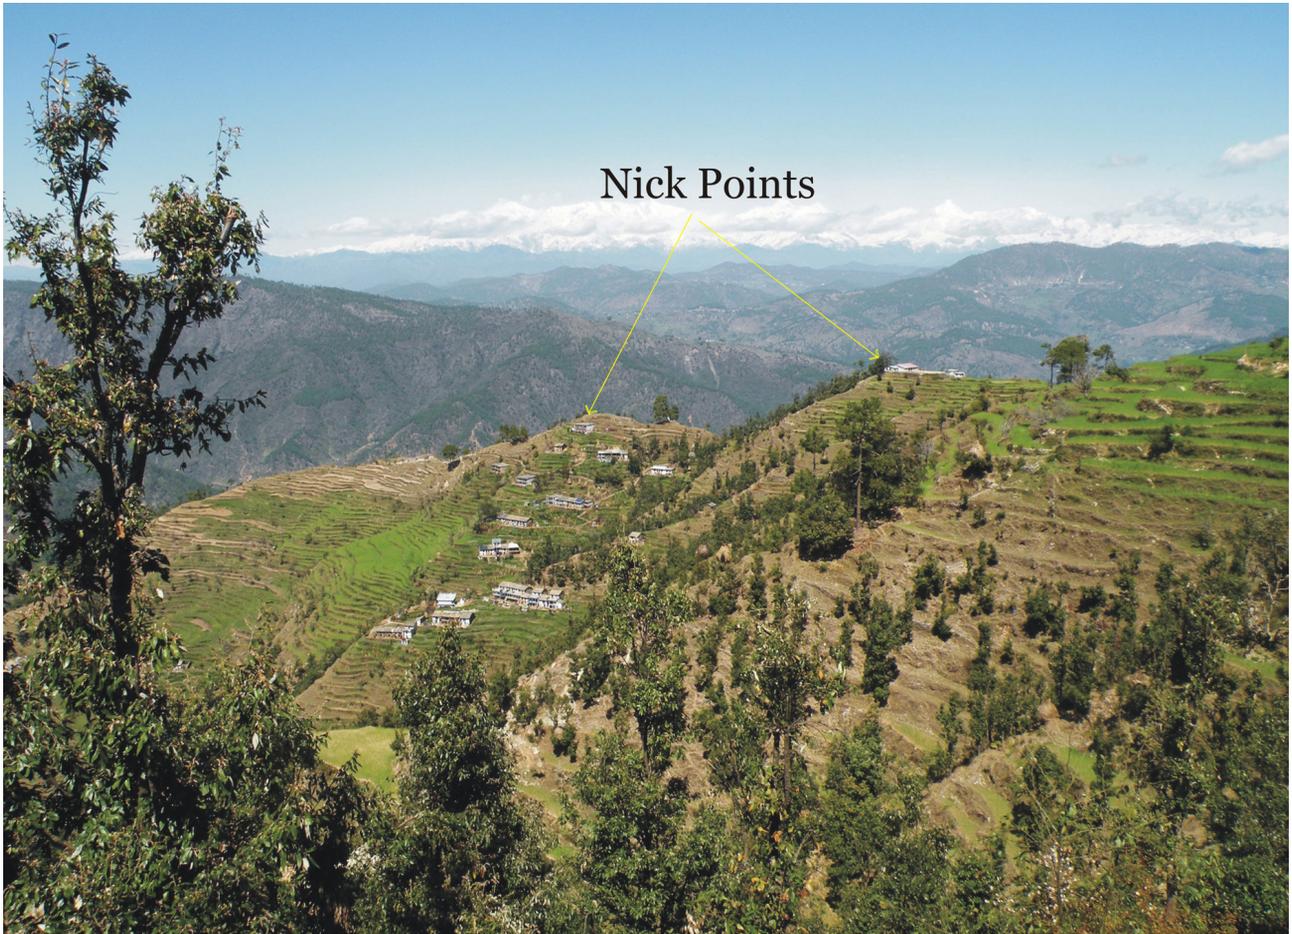
Fig. 3. Nick points along the water divide in Ghuniyoli watershed

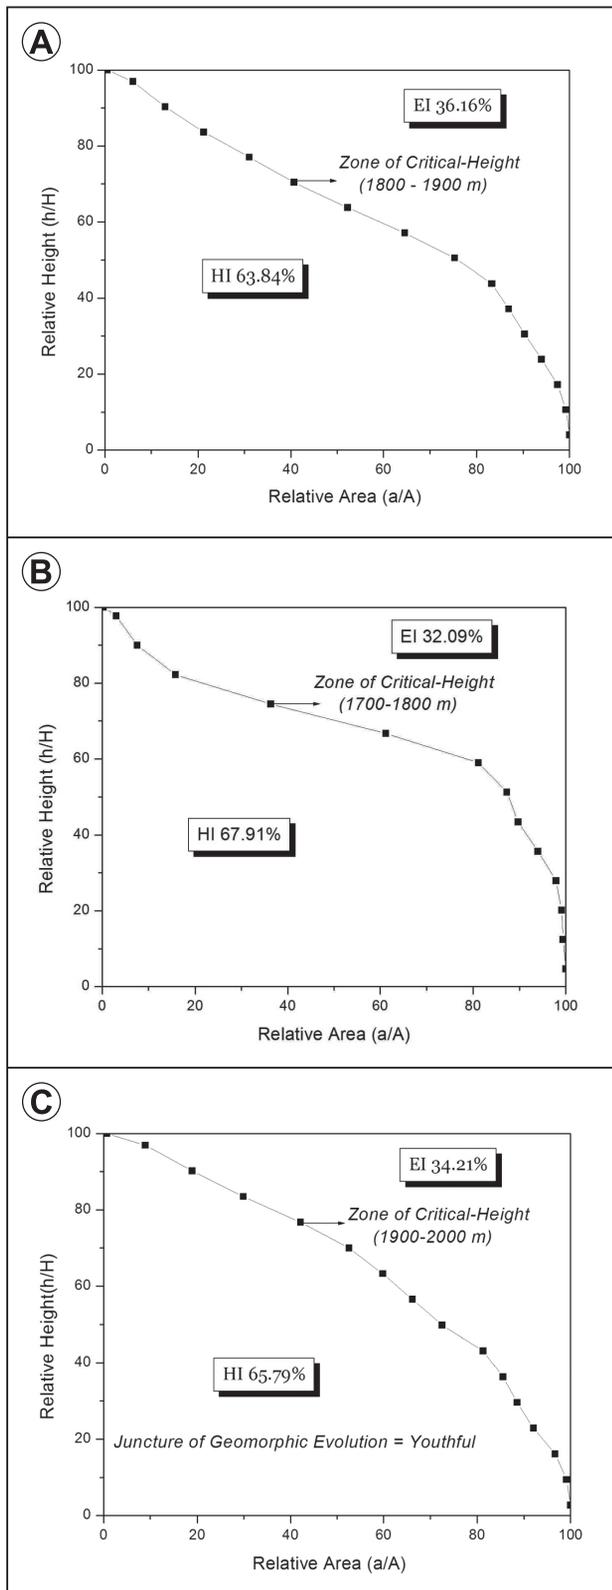
Fig. 4. Stages of erosion and land use in the the Ghuniyoli Gad watershed

A – inact (entire) watershed, B – cultivated land, C – forest land. H – total height of the watershed, h – height between two successive contours, a – area between two successive contours, A – total area of the watershed, HI – Hypsometric Integral , EI – Erosion Integral

The geomorphic evolution (erosion stage) of the watershed was assessed under varying altitudinal variations (Table 2). Further the erosion was evaluated under different land use, i.e. inact land, cultivated land and forest land while barren land was not available in the watershed (Fig. 4A, B, C).

The watershed is under severe land degradation. Out of total Ghuniyoli watershed area, 36.16% area attained stress as a result of erosion. The zone of critical height was 1,800–1,900 m a.s.l. above which the erosion was the most strong. The watershed attained inequilibrium (youthful) stage as per the hypsometric integral (63.84%). In reference to area under intense erosion, the altitudinal zone of 2,200 to 2,300 m a.s.l. contributes maximum area (6.34%) while 900 to 1,000 m a.s.l. zone constitutes minimum area (0.04%) out of the area of the watershed. In reference to area under insignificant erosion, the altitudinal zone of 900 to 1,000 m a.s.l. contributes maximum area (6.96%) while the altitudinal zone of above ($>$) 2,300 m a.s.l. constitutes minimum area (0.09%) out of the area of the watershed.

The cultivated land of watershed was under the severe stress of erosion. Out of total cultivated land, Ghuniyoli watershed possesses 32.09% area under serious threat to erosion. Over the entire cultivated land, the zone of critical height was 1,800 to 1,900 m a.s.l. above which erosion was intense. The hypsometric integral (67.91%) determined the stage of inequilibrium (youthful) for cultivated land of the watershed. In reference to area of the cultivated land under intense erosion, the altitudinal zone of 2,000 to 2,100 m a.s.l. contributes maximum area (7.59%) while the altitudinal zone of 900 to 1,000 m a.s.l. attains minimum area (0.05%) out of the area of cultivated land of the watershed. In reference to area of the cultivated land under insignificant erosion, the altitudinal zone of 1,000 to 1,100 m a.s.l. contributes maximum area (7.92%) while the altitudinal zone of 2,100 to 2,200 m a.s.l. constitutes minimum area (0.03%) out of the area of cultivated land of the watershed.

The forest land was also under the crucial problem of erosion. Out of total forest land, Ghuniyoli watershed attained 34.21% area under severe stress as a result of erosion. Over the entire forest area of watershed, the zone of critical height was 1,900 to 2,000 m a.s.l. above which erosion was acute. The hypsometric integral (65.79%) ascertained the stage of inequilibrium (youthful) for forest land of the watershed. In reference to the area of the forest land under intense erosion, the altitudinal zone of 2,200 to 2,300 m a.s.l. contributes maximum area (6.03%) while the altitudinal zone of 900 to 1,000 m a.s.l. constitutes minimum area (0.04%), out of the area of forest land of the watershed. In reference to the area of the forest land under insignificant erosion, the altitudinal zone of 1,000 to 1,100 m a.s.l. contributes maximum area (6.86%) while the altitudinal zone of above 2,300 m a.s.l. constitutes minimum area (15%), out of the area of forest land of the watershed.

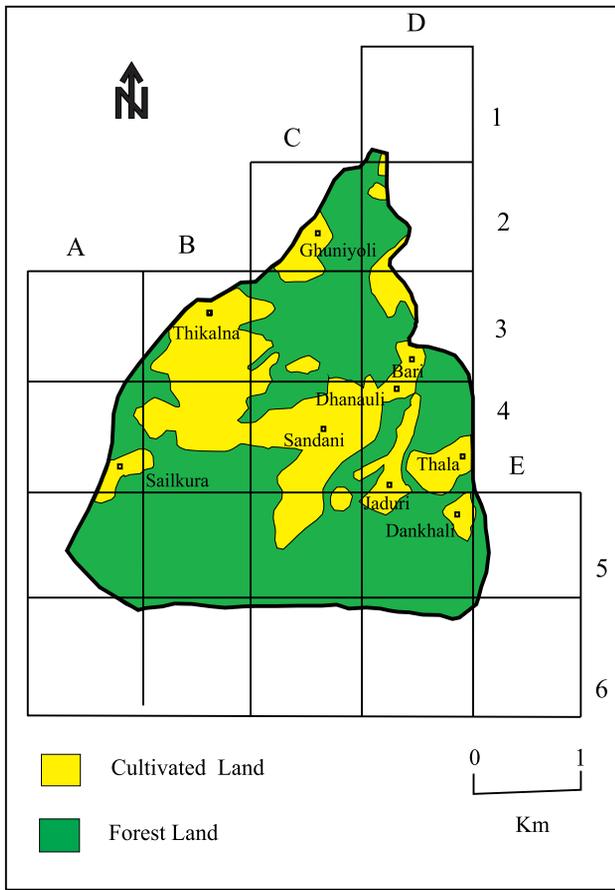
Fig. 5. Study units and land use in the Ghuniyoli Gad watershed

The Ghuniyoli Gad watershed possesses two types of land use/land cover. 32.29% area falls under cultivated land while rest 67.71% area is covered by forest (Fig. 5). Field observations reveal that land use pattern is controlled by geomorphic and climatic conditions. The part of the watershed at altitude from 800 to 1,200 m a.s.l. is covered by forest because the lower part of watershed posses narrow valleys with steep slopes. The upper part has extended valley and moderate slope, but at altitude from 1,800 to 2,346 m a.s.l. extreme climatic conditions (dry) do not allow the habitation and agricultural processes therefore this area is also under forest. Thus middle part at al-

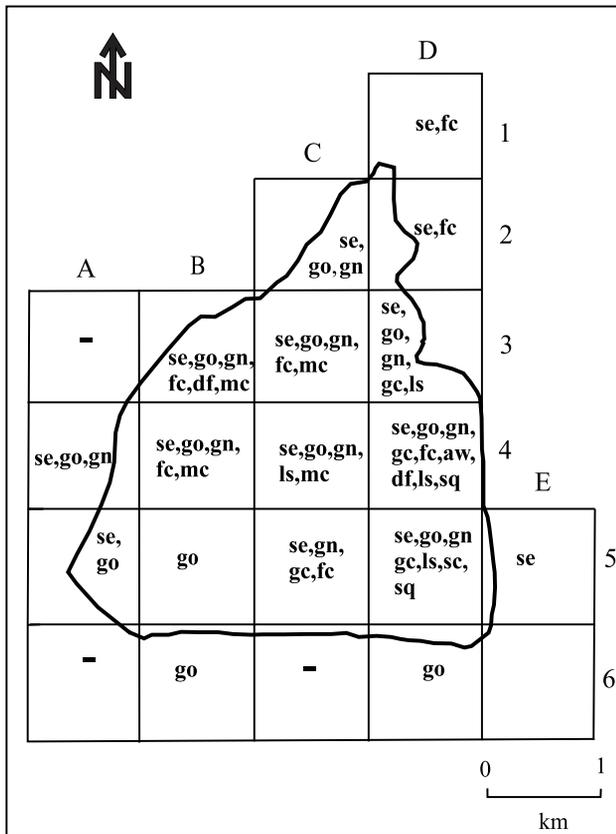
Fig. 6. Types and corresponding degree of confirmed/inferred instability

se – surficial erosion, go – erosion in old gully, gn – erosion in new gully, gc – gully induced collapsing of terraces, fc – flood induced collapsing of terraces, aw – accumulation of water transported material, df – debris flow, ls – landslide, sc – soil creeping, sq – stone quarry, mc – man-induced collapsing of terraces

Eleven types of geomorphic hazards were identified in the Ghuniyoli watershed within twenty one study units (Fig. 6, Table 3) which were grouped into three major hazards: a/ erosion hazards (surficial erosion (se), gully erosion (erosion in old gully (go), erosion in new gully(gn), gully-induced terrace collapsing (gc), flood-induced terrace collapsing (fc), accumulation of water transported material (aw)), b/ mass wasting hazards (debris flows (df), landslides (ls), soil creeping (sc)), c/ anthropogenic hazards (stone quarry (sq), man-induced terrace collapsing (mc)).

which proves the extent of erosion and instability of the area (Table 3, Fig. 6). It was active in old erosional gully in 13 units while in fresh erosional gullies in 10 units only. The gully erosion was prominent in forest area along steeply sloping forest (Fig. 8). Gully induced terrace collapsing was experienced by 4 units (Fig. 6) located within the cultivated land. In the others the new gullies were created in pine forest. Efforts have been done by the inhabitants to manage their cultivated land, yet their efforts were proved fruitless due to geological sensitivity of the terrain consequently the reconstructed terraces were not maintained. Flood induced terrace collapsing was experienced 2 units (Table 3, Fig. 6). Accumulation of water transported material upon cultivated land was found only in one unit (4D) (Table 3, Fig. 6). The debris material transported through new created gully from pine forest area was accumulated upon cultivated land on area of 3,000 m² and disturbed the continuity of agricultural terraces.

Debris flows were observed in two units (Table 3, Fig. 6). In unit 3B debris flow is studied in pine forest area located along Ghuniyoli Gad. The debris flow covers about 30,000 m² area along steep (almost vertical slope) slope. Maximum debris was washed away by Ghuniyoli Gad stream and formed a tongue with badland like topography. Debris flows are active each year during monsoons. Downslope the tongue cutting of pine forest along steep scarp were the observed causes of this hazard. In unit 4D, the debris flow was observed in grassy slope (Jaduri village) surrounded by sparse pine forest. An area of about 24 m² was covered by this debris flow which was protected by check dams in its initial stage. The uppermost part of this debris flow was under the pressure of agricultural processes, thus exaggerating the vulnerability of the terrain.

Man induced terrace collapsing occurred in 3 units while 5 units experienced both type (flood induced and man induced) of terrace collapsing (Table 3, Fig. 6).

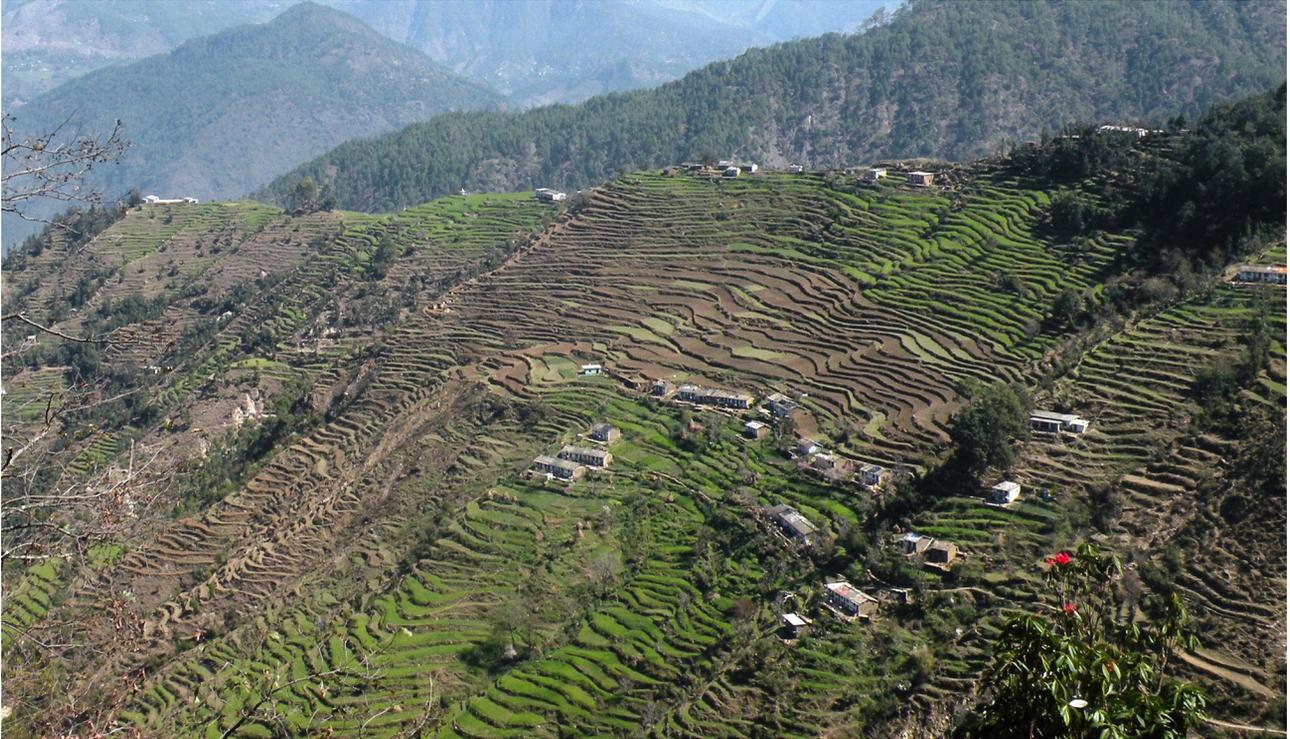
Fig. 7. Subsiding agricultural terraces along steep slope in Thala Village

Surficial erosion (se) is significant in the units with cultivation especially in upper reaches of valley slopes with terraces (Fig. 7). This is observed in fourteen units (Table 3, Fig. 6). Gully erosion is significant under 14 units out of total 21 units of the watershed

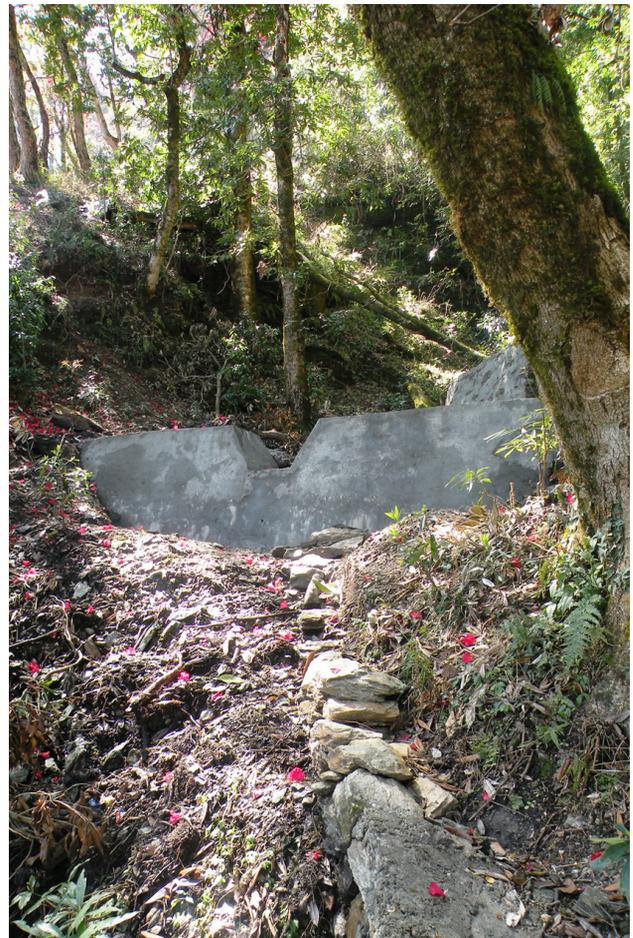
Fig. 8. Debris dam to check gully erosion in forest land

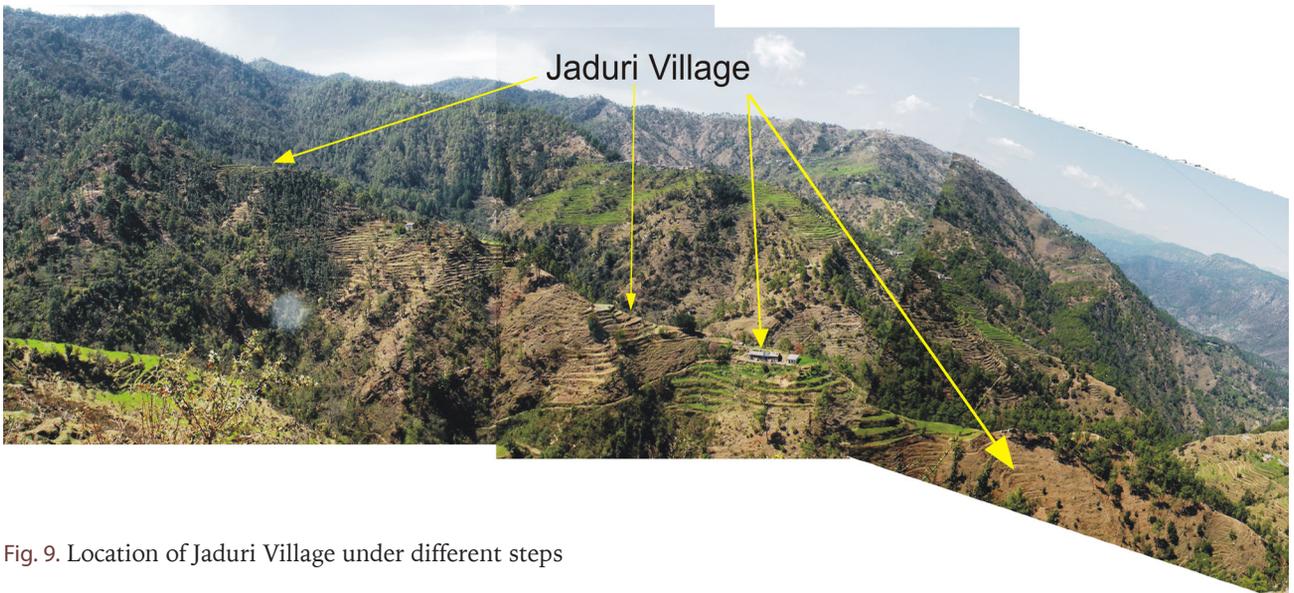
Fig. 9. Location of Jaduri Village under different steps

was again left barren due to the frequent collapsing of terraces due to landslide movement (Fig. 9). In whole Thala village (settlement and cultivated land) is under the grip of landsliding. The discontinuity of agricultural terraces due to landslide has created three gullies within the cultivated land. Consequently the entire cultivated land was divided into three major agricultural zones (Fig. 10). These gullies provide intensive erosion to the area. These were about 1.5 to 2.0 m deep and 1.5 to 2.0 m wide so the collapsing of agricultural terraces in each rainy season has become a common problem as the sufficient rain water accumulates in these gullies. The cultivated land destroyed along these gullies is about 10 1000 m². After rain repairable part of terraces is reconstructed each year to fulfill their food requirements from the agricultural field.

Locality (basic unit)	Altitude [m a.s.l.]	Geographical coordinates	Observed evidences	Causative factors	Area affected by land subsidence hazard [m ²]
Jaduri (4D) Fig. 9	1,700	29°39'47"N 79°51'41"E	a) the houses got cracks during land subsidence. ii. Collapsed agricultural fields and dislocated as evident from their discontinuity Whenever the terraces were reconstructed after land subsidence, the subsided soil forms steeply sloping terraces which were again vulnerable to erosion iv. Check dams were constructed at the toe of the agricultural land along Jalia Gad as well as amid agricultural terraces but these terraces were not remained stable due to the occasional occurrence of land subsidence. The broken and tilted check dams amid the agricultural land and dislocated check dams along Jalia bank speak of the still active process of land subsidence.	Severe toe erosion by Jalia Gad ii. Outwardly sloping agricultural terraces along the hill	4,000

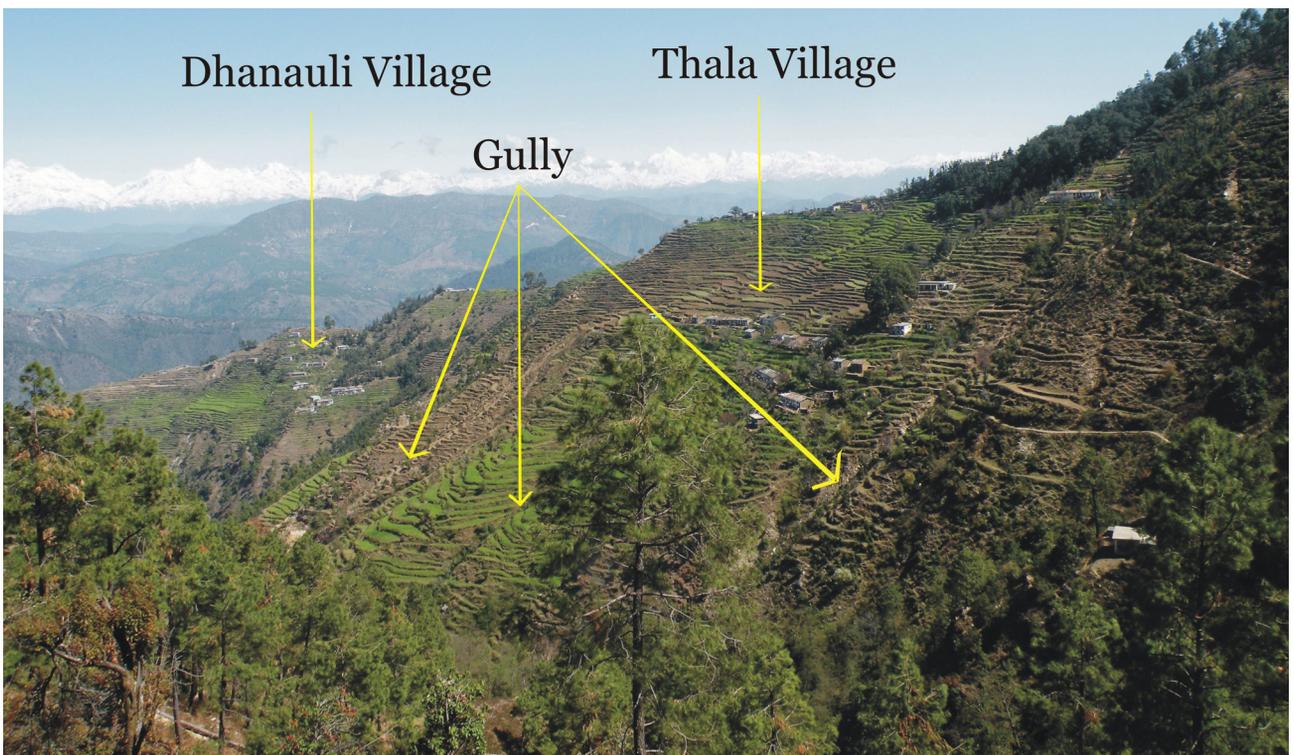
Fig. 10. Location of Thala and Dhanauli village. Gully development within cultivated land in Thala Village

Locality (basic unit)	Altitude [m a.s.l.]	Geographical coordinates	Observed evidences	Causative factors	Area affected by land subsidence hazard [m ²]
Dhanauli (3D) Fig. 10	1,550	29°40'23"N 79°52'07"E	Cracks in houses (3 cases observed) Subsidence of courtyard Subsidence of house stairs iv. Subsidence of agriculture land.	i. Existence of seasonal rivulet at the toe of the affected area.	1,050
Sandani (4C)	1,500	29°40'18"N 79°51'31"E	Damaged agricultural terraces Fissures in the houses iii. Collapsing of courtyard	Existence of Ghuniyoli Gad at the toe of the village ii. Land subsidence was taking place along Ghuniyoli Gad and gradually affecting towards the upper reaches.	337,500
Bari (4D) Fig. 11	1,400	29°40'22"N 79°51'53"E	Discontinuity of agricultural terrace wall and their bulging towards toe ii. Tilting of trees along the crown of affected area. Destruction of trees/plants and consequent creation of gully This gully development caused collapsing of the terraces. The original source of water spring was buried under the debris produced by terrace collapsing and this spring was reappeared in 20 m below from its original place. vi. Construction of regular check dams (30 m length) by Soil Conservation Department along Jalia Gad (tributary of Ghuniyoli Gad) at the toe of Bari village	Severe toe erosion by Jalia Gad ii. Agricultural processes at the crown of the area along vegetation less slope.	16,800

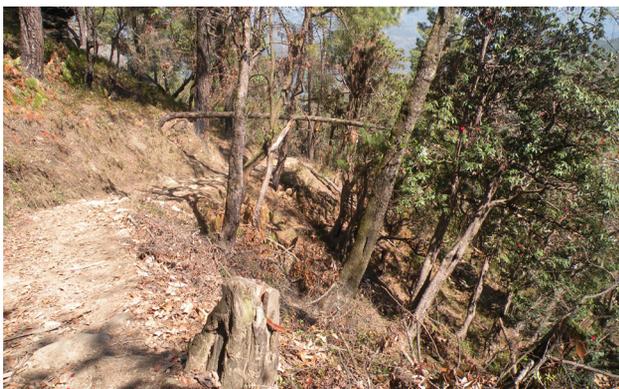
Fig. 11. Tilted trees due to soil creeping

Soil creeping was observed only in one unit, i.e. 5D. A zone covering about 10,379 m² area exists in the Dense Mixed forest. The tilting of huge trees in this particular zone indicates the instability of the forest area where anthropogenic process was negligible and dense mixed vegetation cover seemed to be good protective cover (Fig. 11).

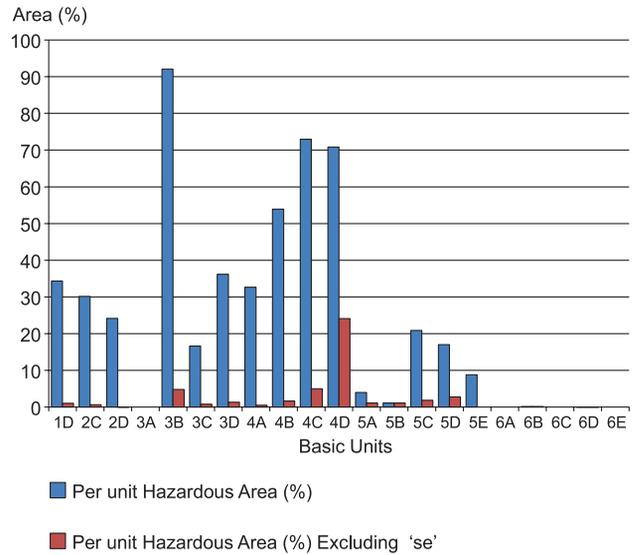
Fig. 12. Area under different hazardous geomorphic processes in particular units

Figure 12 illustrates that surficial erosion (se) covers maximum area under 14 units. Unit 3B is the most hazardous (92.08%) where surficial erosion covers 87.27% area while debris flows also contributes considerably (4.36% area) (Table 5). 4C and 4D units contributes significantly where 73% and 71% area is hazardous and surficial erosion covers 68% and 47% area respectively. Landslides cover about 4% and 23% area of the units respectively. Excluding surficial erosion, the most hazardous unit is 4D where 24% area is hazardous and dominating hazardous process (23%) is landsliding (Table 5).

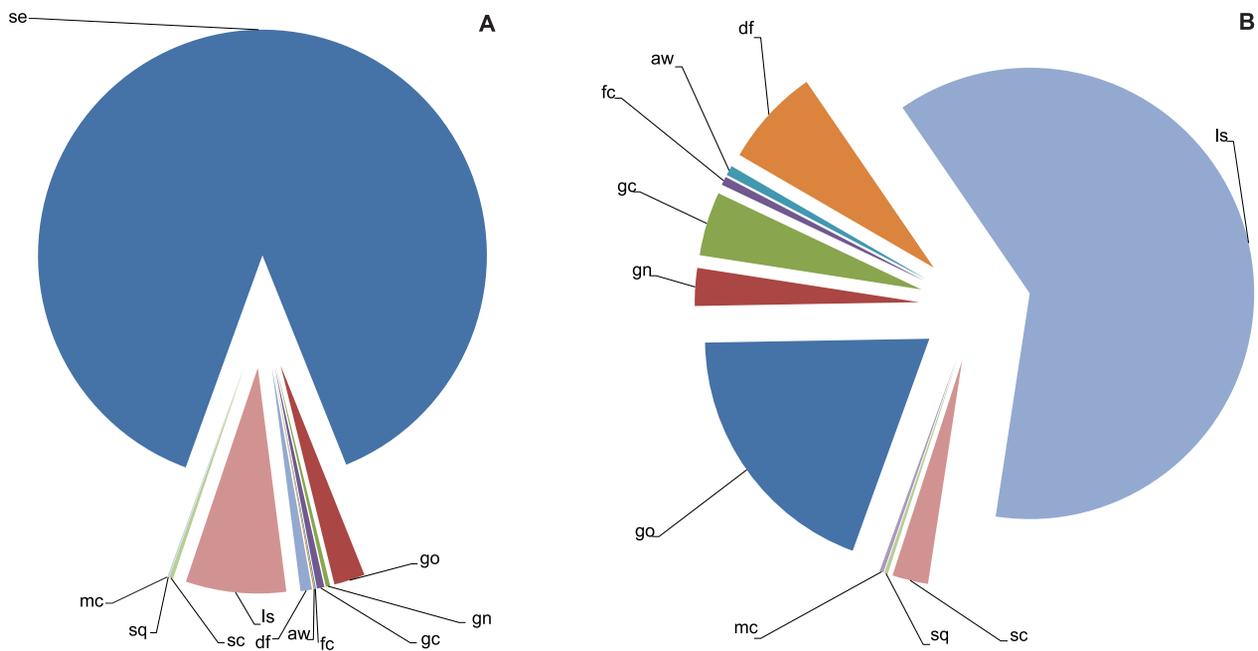
Fig. 13. Area under different hazardous geomorphic processes out of total watershed area
 A – excluding “se”, B – including “se”. Explanations of geomorphic hazards abbreviations see Fig. 6

Figures 13A and 13B exhibit that surficial erosion covers maximum area under the watershed, i.e. 32.29% (Table 6). If surficial erosion is excluded, landsliding (2.64%) covers maximum hazardous area out of total watershed area. Under the assessment of geomorphic hazards in studied units, it is observed that unit 4C (7.15%) followed by unit 4D (6.95%), 3B (6.21%) and 4B (5.28%) cover maximum hazardous area out of total hazardous area of the watershed, i.e. 36.55%. While excluding surficial erosion maximum hazardous unit is 4D, covering 2.38% area out of 4.26% hazardous area of the watershed excluding surficial erosion (Table 6).

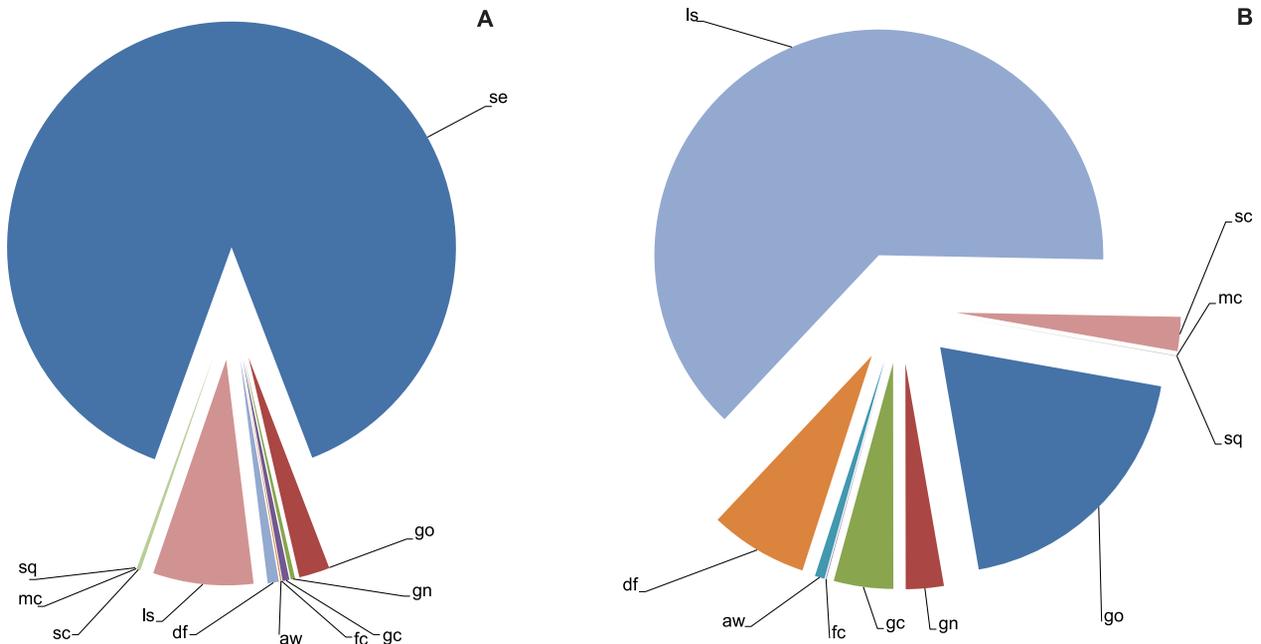
Fig. 14. Area under different hazardous geomorphic processes out of total hazardous area of watershed
 A – excluding “se”, B – including “se”. Explanations of geomorphic hazards abbreviations see Fig. 6

Figures 14A and 14B exhibit that out of total hazardous area of the watershed, surficial erosion covers maximum area i.e. 88.58%. If surficial erosion is excluded, landsliding (63.24%) covers the most hazardous area (Table 7).

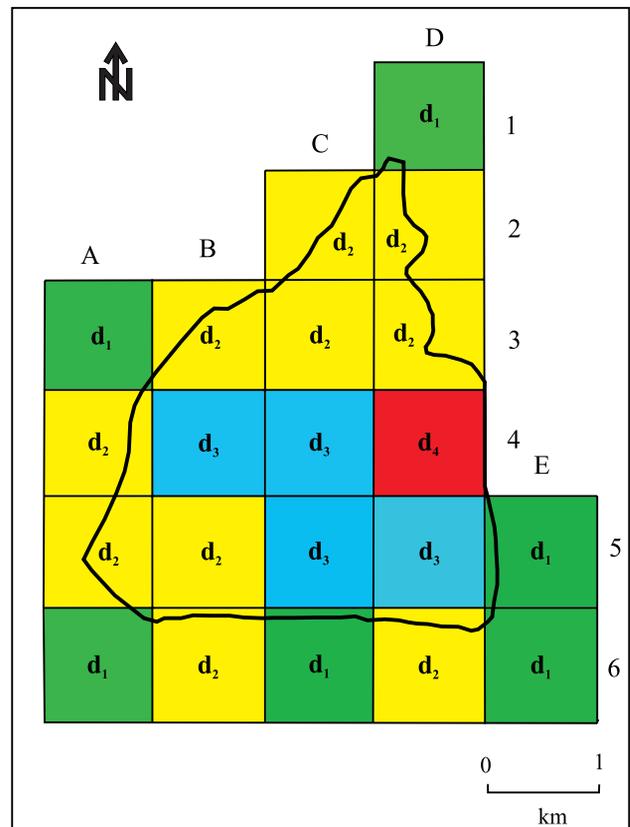
Fig. 15. Types and corresponding degree of suspected instability. d₁ – in case of future mismanaged land use the instability is suspected, d₂ – up to 25% of affected area is suspected to be unstable, d₃ – 25% to 50% of affected area is suspected to be unstable, d₄ – more than 50% of affected area is suspected to be unstable

The watershed was classified using four degrees for inferred instability (Fig. 15). There are 4.76% basic units where more than 50% of the affected area is suspected to be endangered (degree 4). There are 19.04% basic units where 25% to 50% of affected area is suspected to be endangered (degree 3). There are 38.10% basic units

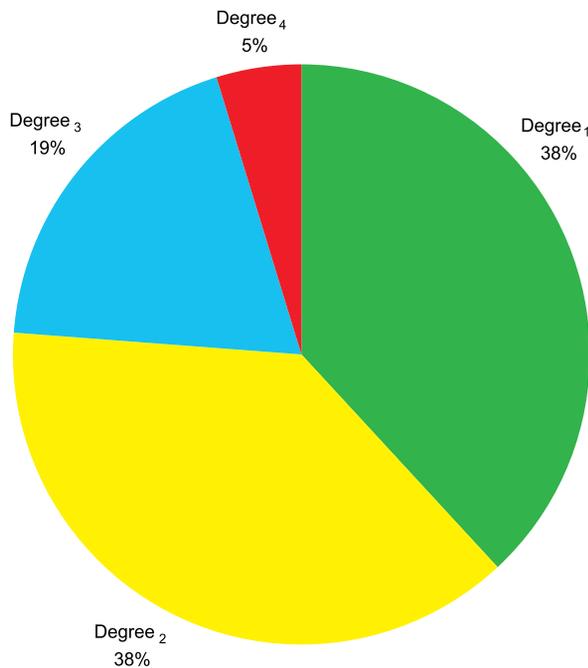
Fig. 16. Assessment of potential geomorphic hazards: percent of units under different corresponding degrees of suspected instability. Explanations of degrees of instability see Fig. 15

where less than 25% of the affected area has potential for future damage (degree 2) and 38.1% basic units where degree of instability (degree 1) is suspected to be high in case of future mismanaged land use. Maximum basic units were in favour of degree 1 and degree 2 categories while minimum basic units were in favour of degree 4 category (Fig. 16). So deprivation of watershed is under the control of recovery and there exists possibilities to improve the degraded environment by mitigating the hazardous processes in watershed.
