**Initial field survey report of the 2011 East Japan Tsunami in Sendai, Natori  
and Iwanuma Cities**

**2011/07/10**

**UNESCO-IOC International Tsunami Survey Team**

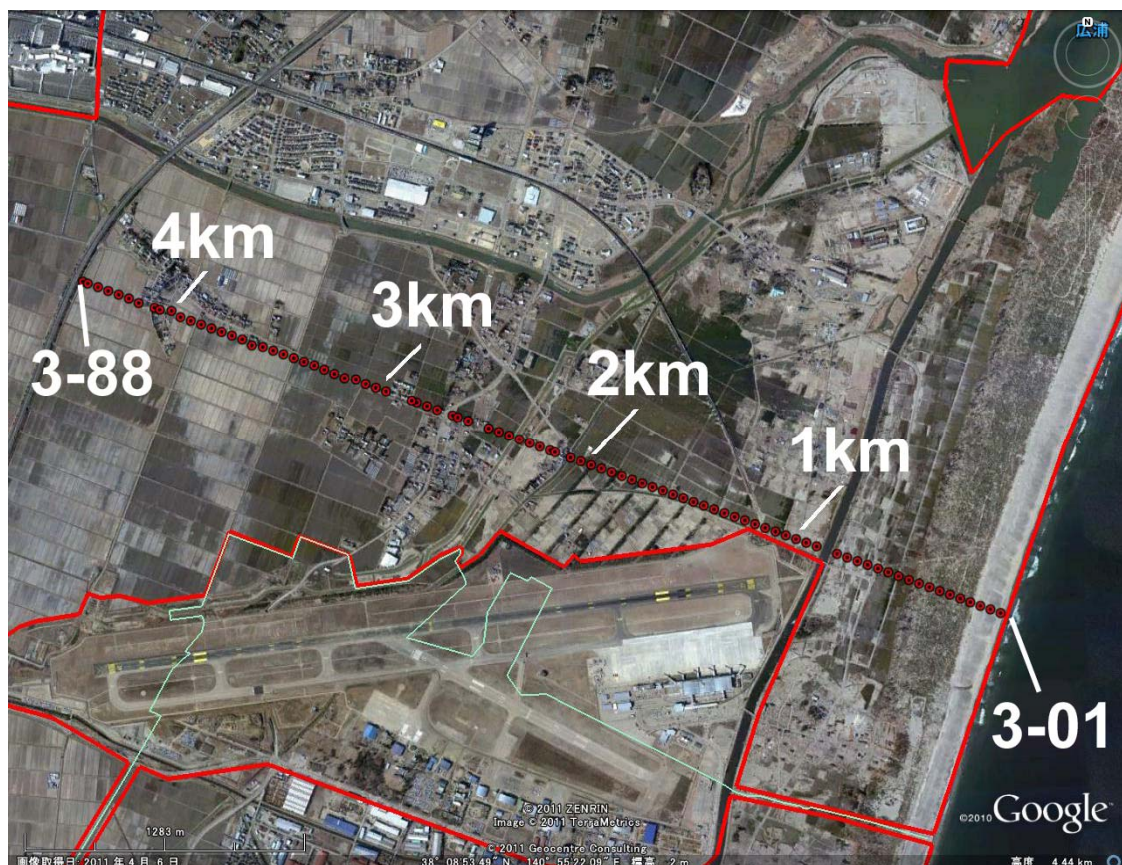
We conducted an initial survey of Sendai, Natori and Iwanuma Cities to confirm that it was possible to carry out a full survey under the existing conditions. An area just north of Sendai Airport (Natori City) was chosen as the location for a survey line. The 4.4 km long transect encompassed a representative area of damaged housing, roads and paddy fields (Fig. 3). GPS measurements of ground elevation and inundation heights were taken along this transect. We surveyed modes of sedimentation and erosion at 70 study sites spaced 50 to 100 m apart along the transect. Additional sites were sampled farther inland, as well as on either side of the transect, for assessment of environmental impact (level of saltwater contamination in soil underlying the tsunami deposit). The specific conductivity of water in paddy fields, canals, irrigation and drainage channels was also measured to assess the salinity. Study sites were numbered from 3-01 to 3-88 in a seaward to landward direction.

**Figure 3.** Location of the survey line studied (modified from Google Earth image).

Figure 4 shows the ground elevation above Tokyo Peil (TP, mean sea level in Tokyo Bay). The ground elevation is generally around 3-4 m at the coastal dunes and 0-1 m in the inland paddy fields except where roads and other elevated structures were present. The paddy fields are visible as the dark colored areas in the satellite image (Fig. 3) and these also generally correspond with water-covered sections of the transect.

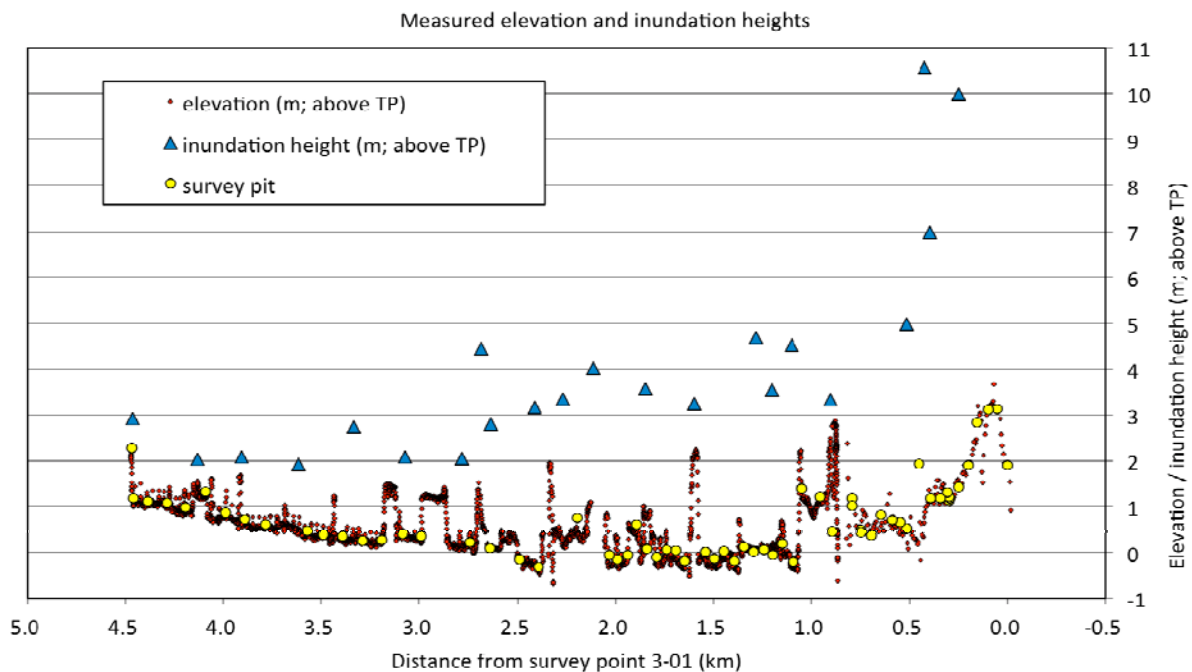
Inundation heights 10.6 m above TP (flow depth 9.6 m) were measured immediately landward of the coastal dunes. Between 0.5 and 2.5 km inland the inundation height was 3-4 m above TP (flow depth 2-3 m). At the landward end of the transect over 4 km from the ocean the flow depth was only about 20 cm where the ground elevation was 2.7 m adjacent to the Tobu Highway. Most of the severe damage to houses and roads occurred across a zone from the coast to around 2.5 km inland where flow depths were highest.

**Figure 4.** Inundation height and ground elevation after the earthquake and tsunami along the survey line.

Ground elevation is lower than mean sea level in several places between the landward side of the coastal dunes to around 2.5 km inland because of coseismic subsidence coupled with erosion by the tsunami. Thus the drainage infrastructure will need to be enhanced to ensure that seawater incursion is reduced and that freshwater flooding during heavy rain is controlled.

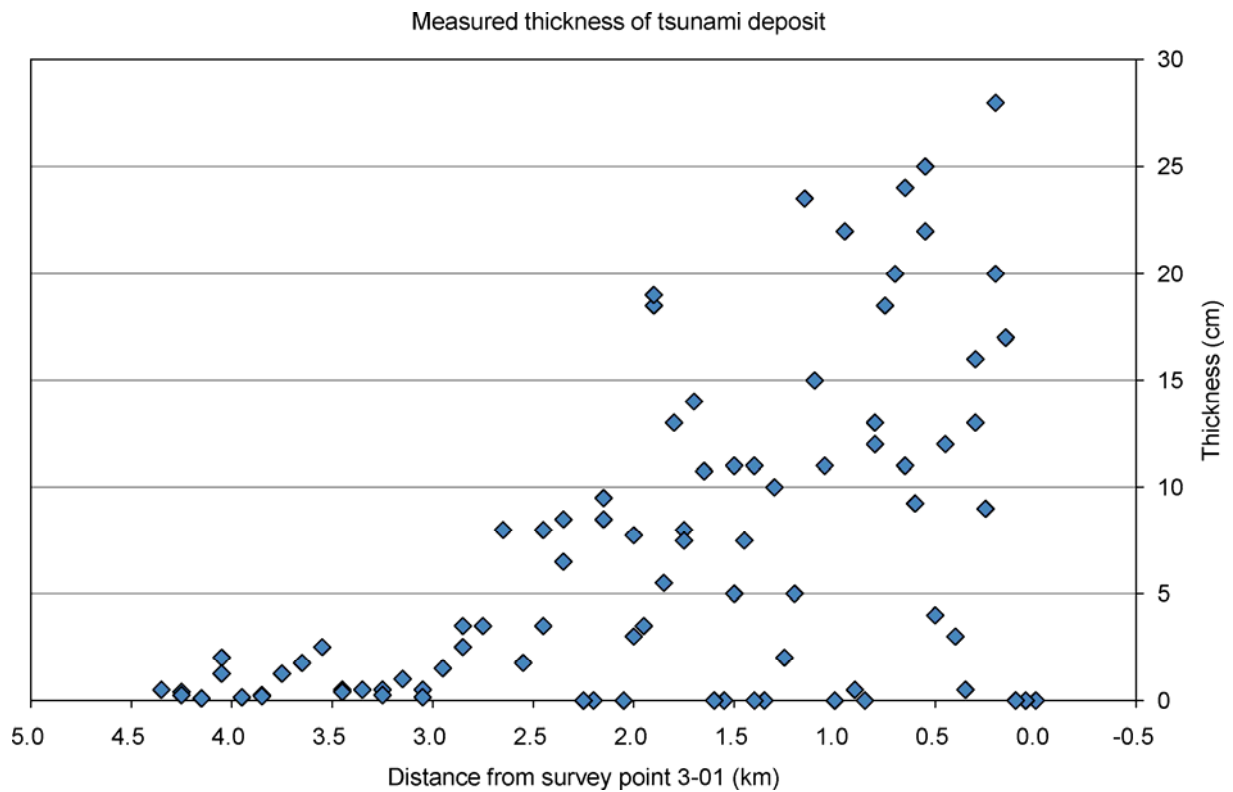
Figure 5 shows the thickness of the sediments deposited by the tsunami (tsunami deposit). The tsunami deposit generally thins landward ranging from 15-20 cm thick 1 km inland, to about 10 cm thick 2 km inland and less than 5 cm thick 3 km inland. Observations in a few pits around each study site showed that the thickness of the tsunami deposits varied significantly over short distances. Evidence for both erosion and deposition was common at sites that were at similar distances inland. Erosion however, was predominant on the landward side of elevated features such as breakwaters or coastal dunes.

**Figure 5.** Measured thickness of the tsunami deposit (sand and mud) along the transect.

The removal of some of the tsunami deposit will probably be necessary to restore some of the paddy fields for cultivation. The tsunami deposit is 10-15 cm thick in an area between 1.0 and 1.5 km landward from the shore. In places, it also contains black mud, which probably originated from the canals (Teizan and Hakken Canal), and has high salt content and may also contain iron sulfide that can harm crops. Agricultural soil will need to be re-established in the area up to about 1.7 km from the shore, where collapse due to liquefaction and soil erosion by the tsunami are predominant. The area further than 2.5 km inland can be restored without removal of the tsunami deposit, because it is less than 5 cm thick and contains little sand.

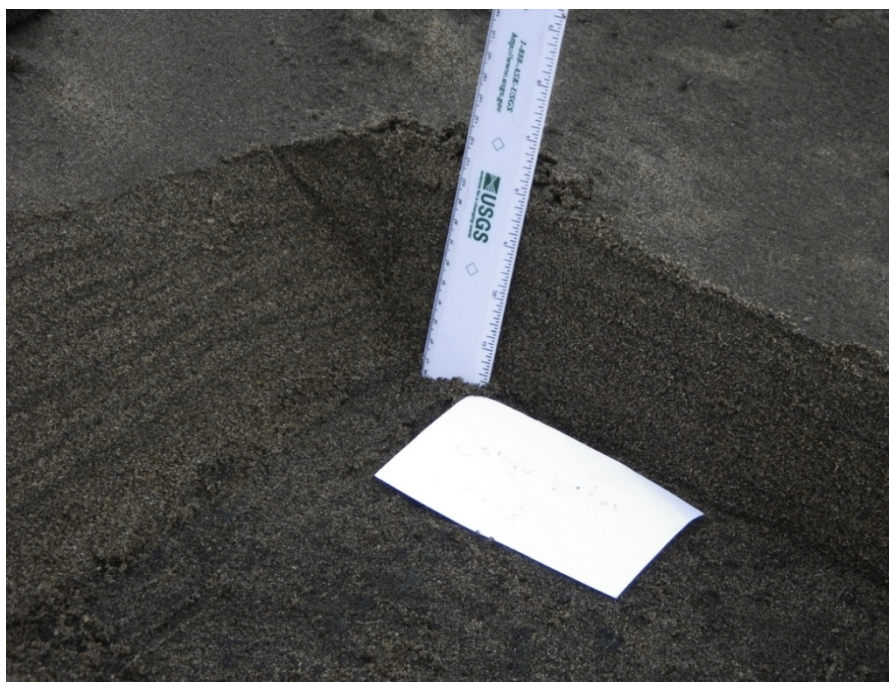
The tsunami deposit was composed mainly of sand within 1 km of the ocean (Fig. 6) changing to sand

**Figure 6.** 20 cm thick tsunami sand deposit at site 3-12 (550 m from shore, Natori City).

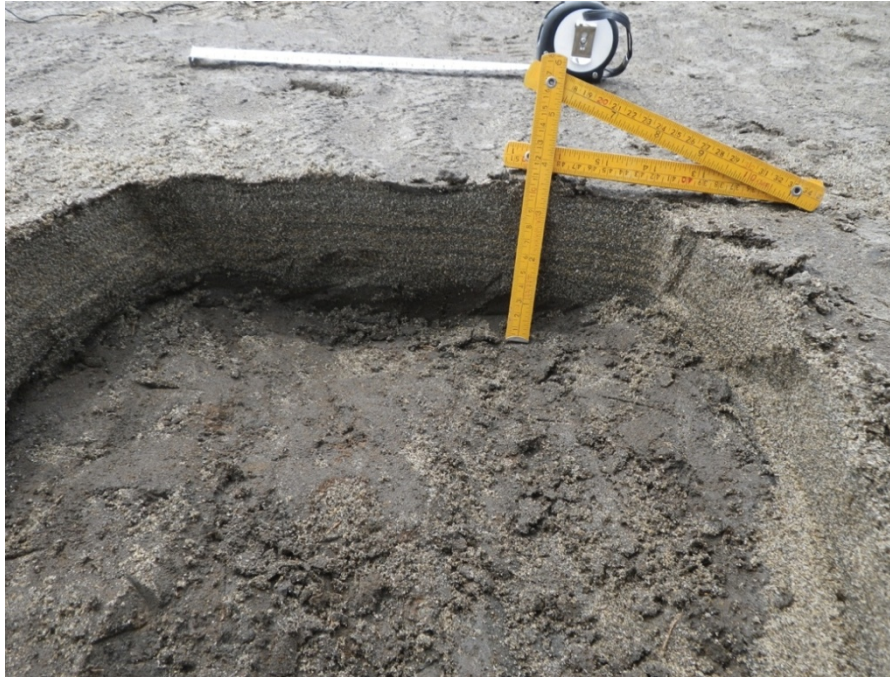
covered by about 5 mm of mud between 1-3 km from the shore (Fig. 7). Further landward of 3 km from the shore, the deposit was composed almost entirely of mud underlain by a very thin (<1 mm thick) lamina of fine to very fine sand (Fig. 8). Numerous soil rip-up clasts were observed on some of the more seaward paddy fields.

**Figure 7.** Tsunami deposit at site 3-30 (1.45 km from shore, Natori City) composed of 7 cm thick sand overlain by 5 mm thick mud.

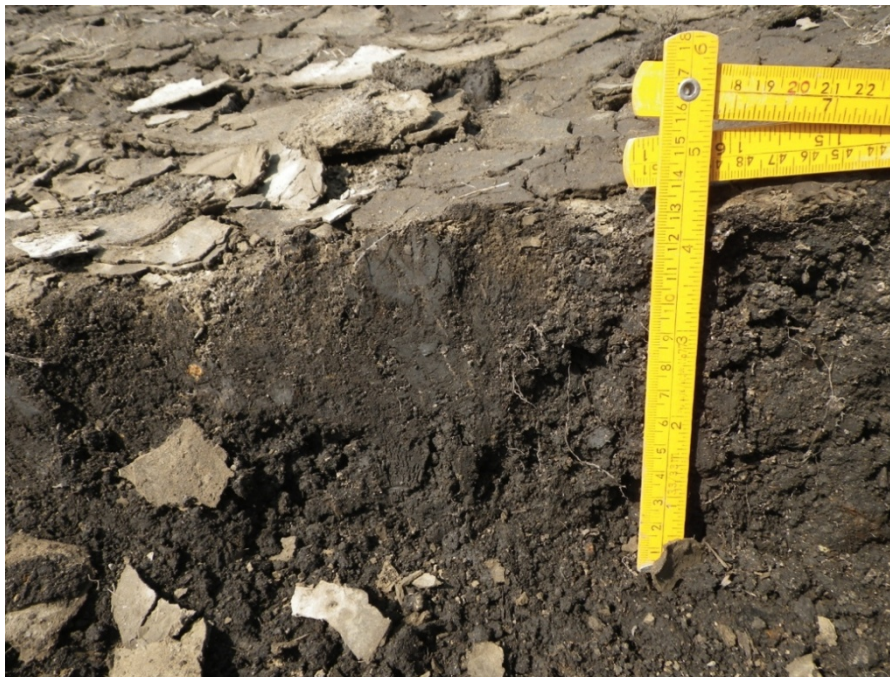
**Figure 8.** Tsunami deposit at site 3-64 (3.15 km from shore, Natori City) represented by a 5 mm thick mud layer.

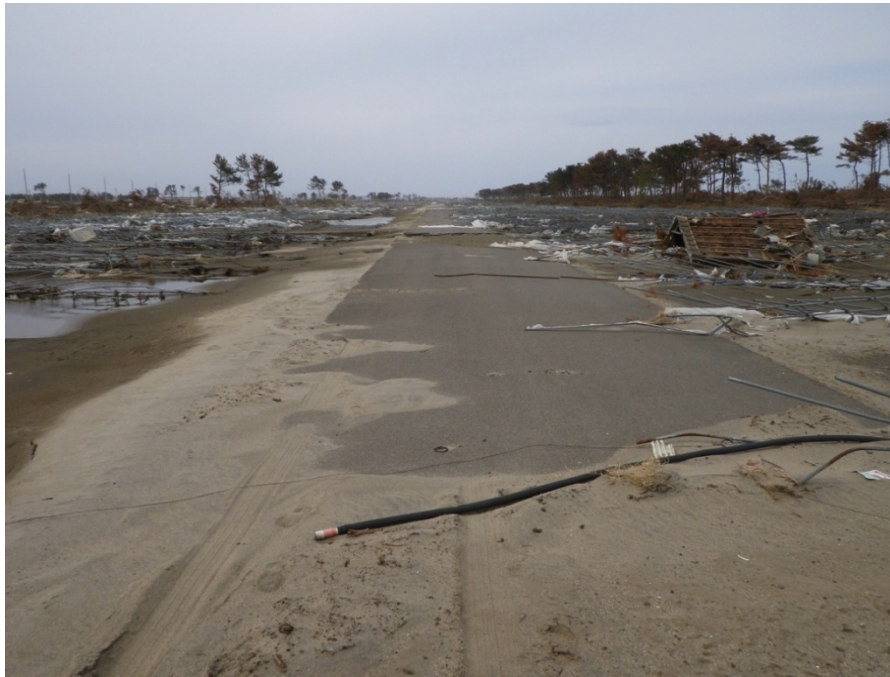
Ground level lowering due to erosion and dewatering from liquefaction was observed at several places along the transect (Figs. 9, 10). The tsunami deposit therefore appears to consist mainly of sand transported from the beach and dunes east of the coastal forest, mud from the erosion of paddy field soils west of the

**Figure 9.** Remains of greenhouses north of site 3-10 (450 m from shore, Natori City). According to interviews, the surface of the farmland was at about the same level as the road prior to the tsunami, but erosion during the tsunami removed sediment from the farmland resulting in the elevation difference apparent in the photograph.

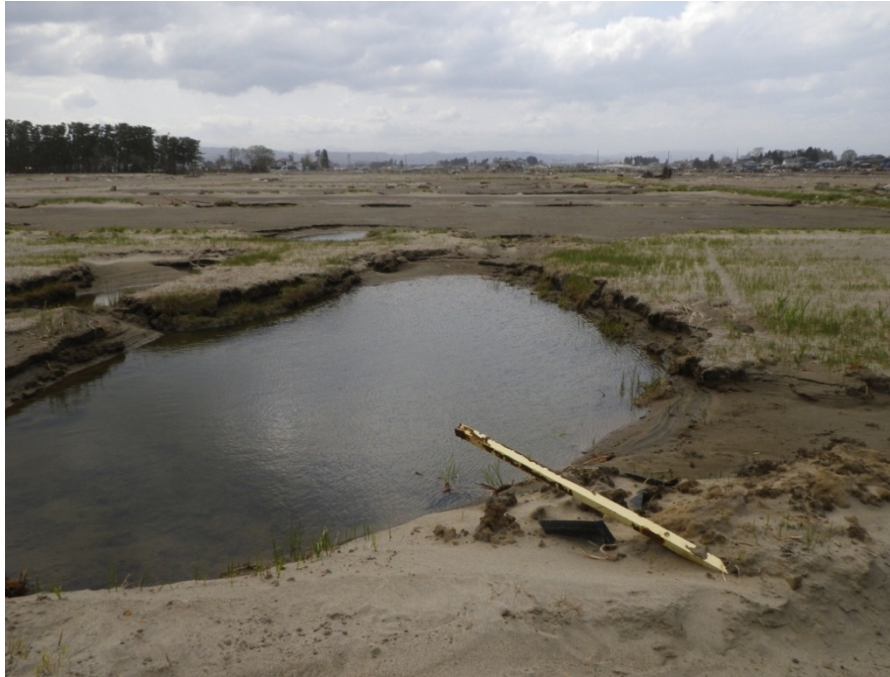
**Figure 10.** Possible liquefaction features close to site 3-32 (1.55 km from shore, Natori City). The depressions are thought to be due to sand liquefaction and collapse of the surface soil and were likely modified by erosion by tsunami waves. Liquefied sands would have been entrained and transported inland by the tsunami.

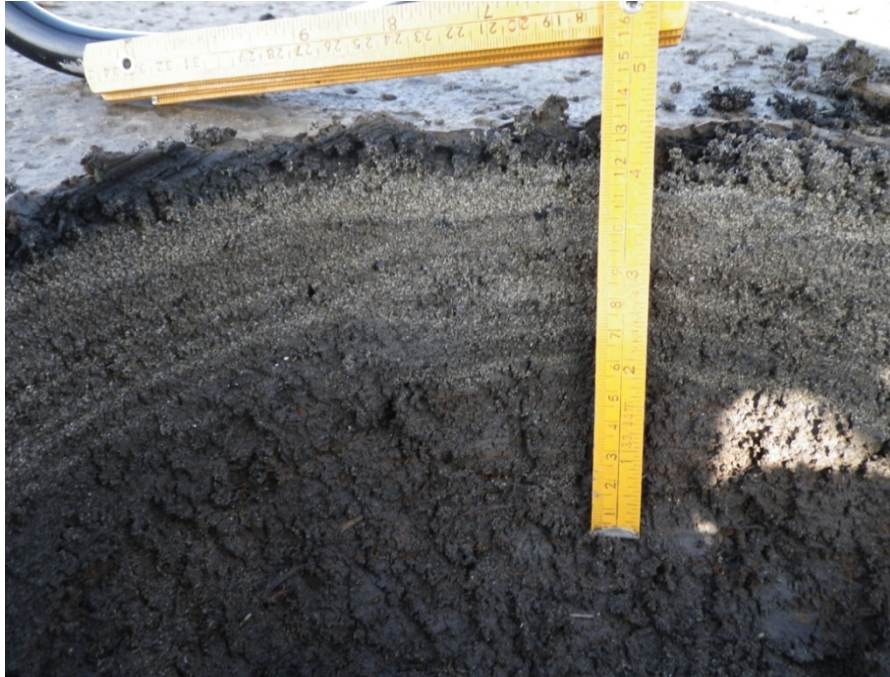
It appears that the mud overlying the sand in the tsunami deposit was laid down from standing water. Most of this fine material was most likely sourced from soil eroded from paddy fields (sometimes incorporated as rip-up clasts), although deposition of seafloor mud mixed with terrestrial mud is also likely. Furthermore, black colored mud covering paddy fields was reported immediately landward of Hakken Canal (Fig. 12). The black color most likely indicates that it was sourced from the bottom of the canal where the oxygen-depleted mud is rich in organic matter and/or iron sulfide, and preliminary chemical analysis appears to support this.

**Figure 12.** Tsunami deposit at site 3-48 (2.35 km from shore, Natori City) showing a 7 cm thick sand covered by 1.0-1.5 cm thick black mud.

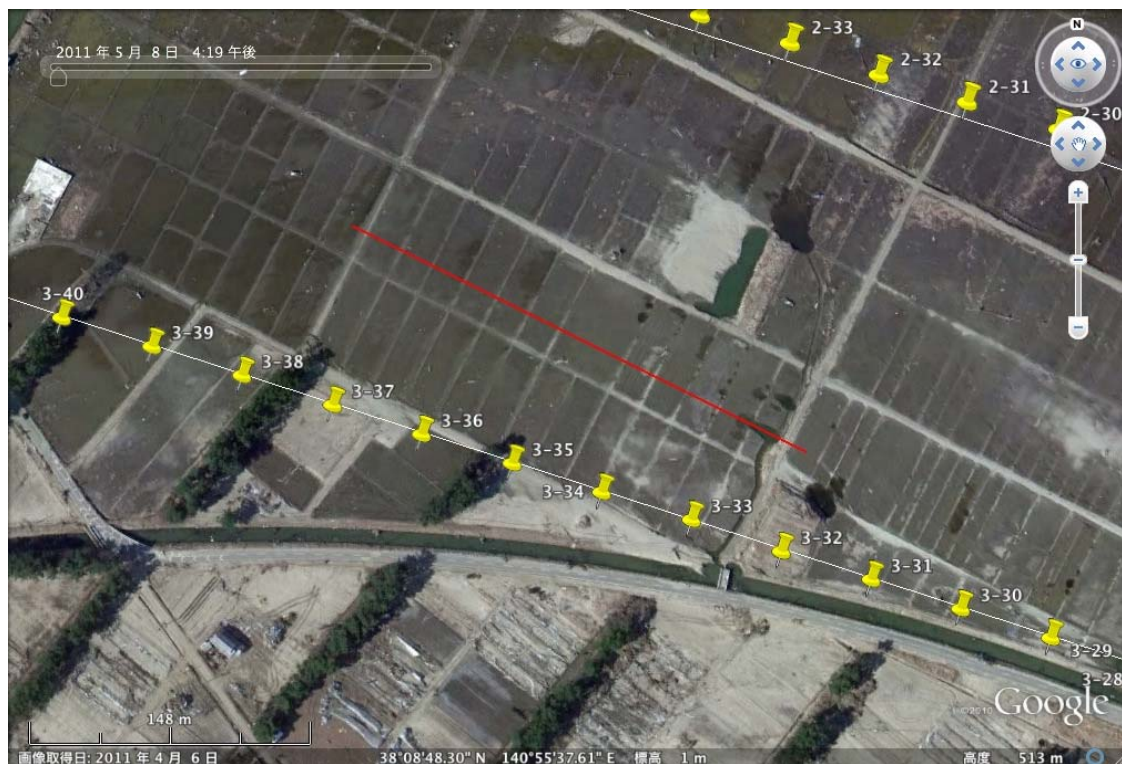
We established an additional transect line 280 m long across footpaths in adjacent paddy fields close to the sites between 3-32 and 3-38 in order to undertake more detailed thickness measurements (Fig. 13). An examination of the thickness of the tsunami deposit and ground elevation indicated that the landward side of footpaths was eroded, while deposition occurred on the seaward side (Fig. 14). Furthermore, vegetation on the footpath was eroded and torn off in many places (Fig. 15).

**Figure 13.** Location of the additional survey line 1.5-2.0 km from shore (red line, modified from Google Earth image).

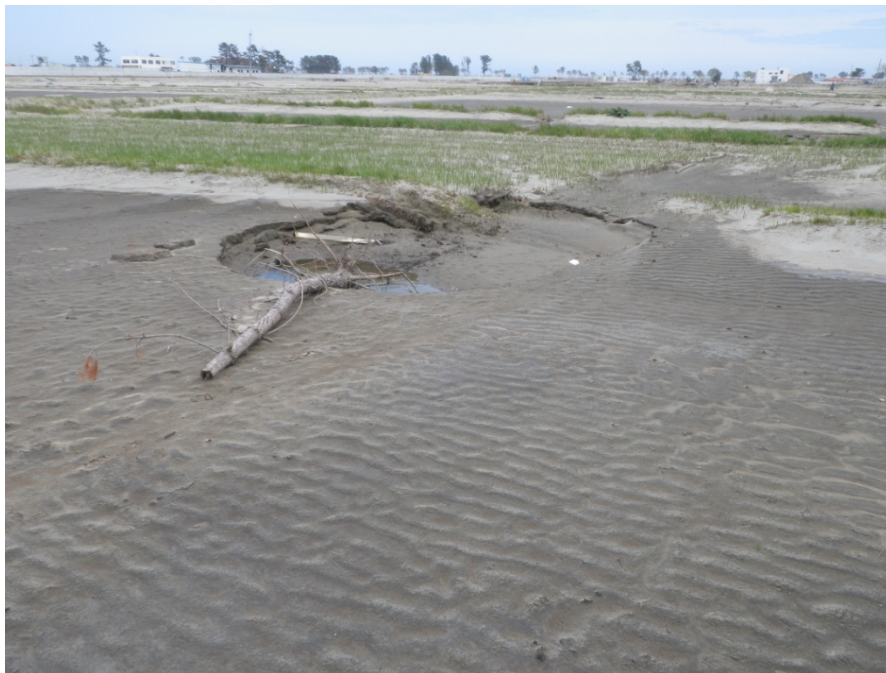
**Figure 15.** Eroded and torn vegetation from footpaths by paddy fields, near site 3-32.

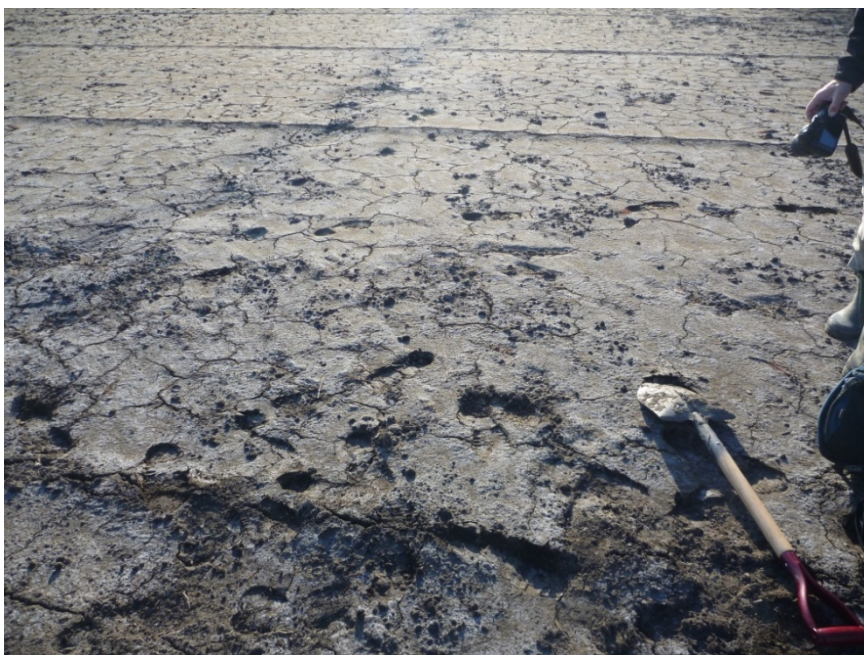
Figure 16 shows the specific conductivity of water in the paddy fields, canals, irrigation and drainage channels. The specific conductivity of ponded water on the paddy fields was 10-20 mS/cm, although it was considerably higher in the vicinity of the canals (Teizan Canal and Hakken Canal) with values exceeding those for seawater in some places (between 2.0-2.5 km inland it reached nearly 70 mS/cm). This high salinity results from the evaporation of seawater introduced by the tsunami. This abnormal saltwater influence is limited to the areas immediately surrounding the canals, although high specific conductivity was still recorded on paddy fields throughout the first 2.6 km of the transect. No ponded water was recorded along the transect further inland, but salt crusts were observed in many areas along the transect (Fig. 17).

**Figure 17.** Salt crust at surface of paddy field, near site 3-64.

Between tsunami inundation and our survey in early May the salinity of ponded saltwater increased through evaporation and minimal dilution due to limited rainfall. A number of saltwater removal operations may be required if dilution by rainfall is insufficient to bring salinities to an acceptable level in the near future. This needs careful monitoring.
