Deformation of a modern alluvial plain

A.J. (Tom) van Loon*

Abstract

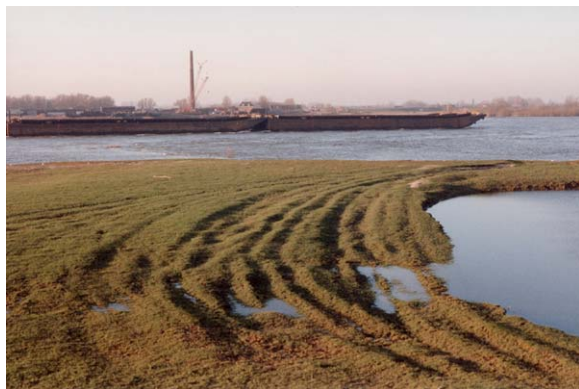
Fig. 4. The parabolic-shaped crests in the alluvial plain as visible shortly after the first 1995 flooding.

The structures described here (Fig. 4) were discovered immediately after the study area had fell dry. A second, much less intense, flooding started several days later and lasted 1 week; when the area fell dry for the second time, the structures were still present without any observable modifications (Fig. 5). According to earlier observations, the structures had

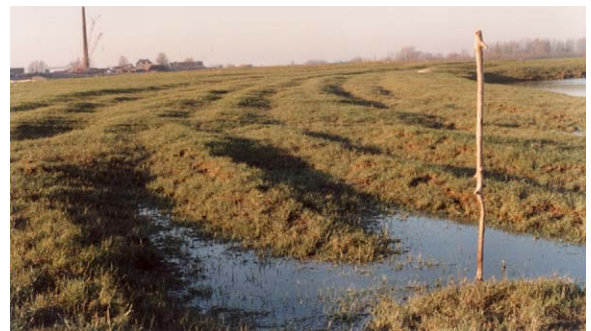
Fig. 5. The deformation structures in the alluvial plain as visible after the area had fallen dry after the second 1995 flooding. The stick above the water is exactly 1 m long.

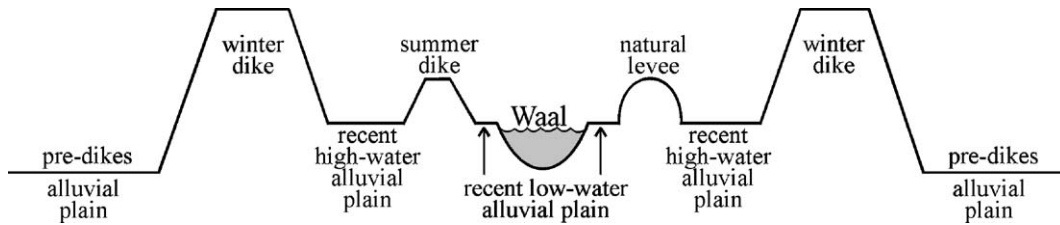
Fig. 6. Schematic cross-section through the Waal River and its alluvial plains (not to scale).

The study area forms part of the alluvial plain of the Waal. The river shows considerable variations in discharge with the seasons. This results in a relatively narrow stream ($\sim 250\text{--}500\text{m}$ in the study area) during low-discharge periods, with the Waal flowing in the main channel, and bordered by either natural highs (old bars, natural levees) or artificial ones (so-called summer dikes). In high-discharge periods, the river overflows the bars, natural levee, and summer dikes, spreading out on both sides over the alluvial plain (thus resulting in a river width of some $1250\text{--}1750\text{m}$) that is bordered mainly by the so-called winter dikes, which are considerably higher than the summer dikes (Fig. 6).

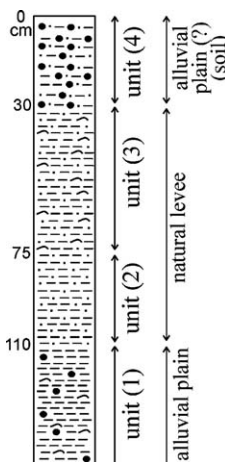
Fig. 7. Profile of the top meters in the deformed alluvial plane and interpretation of its depositional environments.

The boring (Fig. 7) yielded a profile of sediments that can be grouped into four units, from bottom to top:

- (i) a lower unit (1), reaching down from 110 cm beneath the surface and consisting of light brown clays with small shell fragments and coloured spots from manganese concentrations. The groundwater table was reached at –205 cm, and boring through the dark, wet clay underneath was

- (ii) The lower unit (1) passes gradually upwards into an intermediate unit (2), which reaches from -110 to -75 cm and consists of clays and clayey loams that have a sticky consistency. Small shell fragments are present and rusty spots occur.
- (iii) The intermediate unit (2) gradually passes upwards into a top unit (3) from -75 to -30 cm. This unit consists of clayey loam with shell fragments and rusty spots (this unit differs from unit (2) in that the clay is not sticky).
- (iv) Unit (3) is followed gradually by unit (4), reaching from -30 cm to the surface and consisting of a very dark brown crumbly humic loam.

Unit (1) is interpreted as representing alluvial-plain sediments, whereas unit (2) is interpreted as representing the sediments of a natural levee. This is in accordance with the local topographic expression. In 2002, after an earlier phase of high discharge, part of the natural levee at the study site was eroded, and the vertical cliffs formed showed sedimentary characteris-

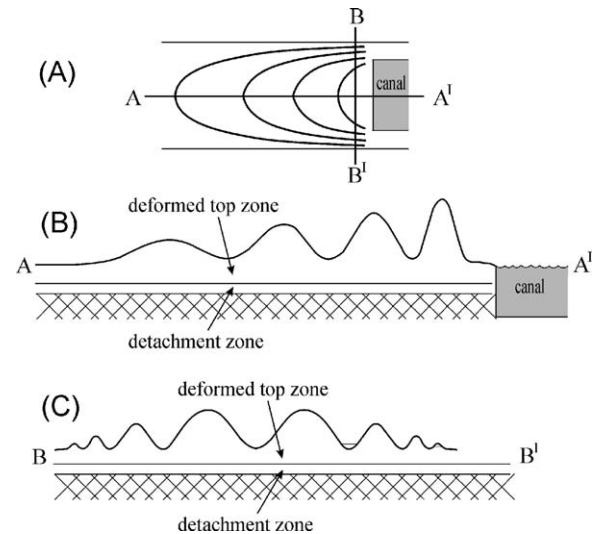
Fig. 8. Schematic characteristics of the parabolic-shaped ridges (not to scale): (A) plan view, with position of the schematic longitudinal and transverse cross-sections; (B) longitudinal cross-section; (C) transverse cross-section.

The overall structure of the deformed area (Fig. 8), which covers $\sim 4000\text{m}^2$, closely resembles that of a plastic mass flow, constituting a number of parabola-shaped folds (Fig. 9). The structure displays the following characteristics:

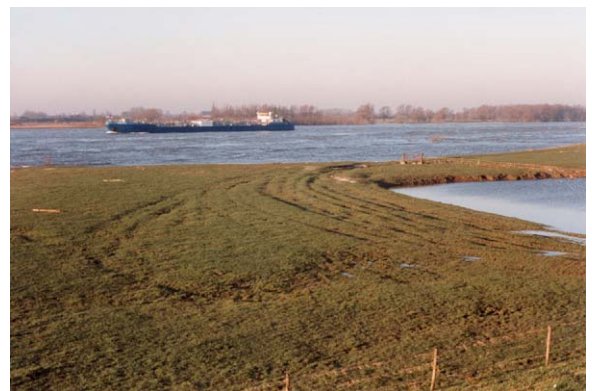
Fig. 9. Southward view of the deformed area near the "canal" (right), showing the parabolic-shaped deformations.

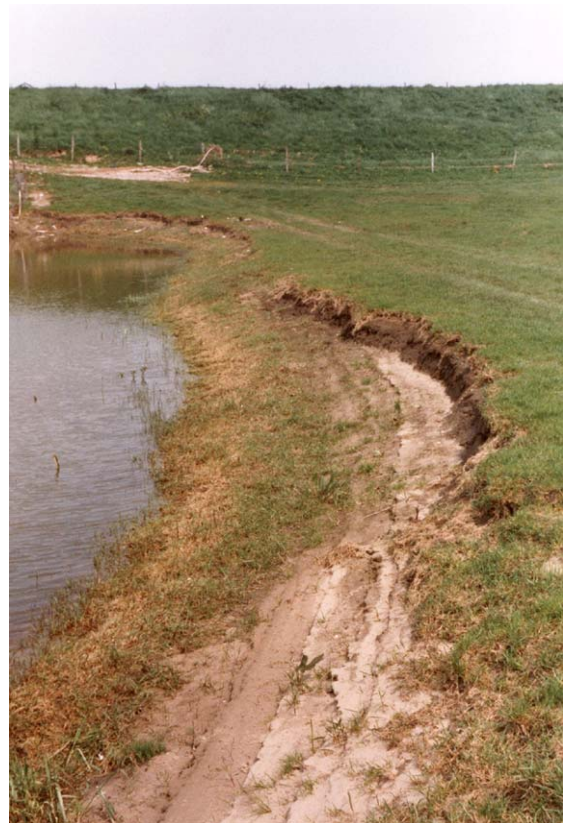
Fig. 10. “Cliff” in the wall of the “canal” formed due to erosion by an “upstream” current from left (=west) to right (=east).
