Slope relaxation following landslides in the Łososina River Basin, Beskid Wyspowy Mts., Poland

Abstract: The paper presents results from a study of the functioning of slopes in conditions where the dynamic equilibrium has been upset and sliding has been followed by slope relaxation. The research was an attempt to analyze large-scale changes in slope morphology in the Łososina River basin in the Beskid Wyspowy mountain range caused by an extreme rainfall event in 1997. The enormous scale of the sliding process that occurred on the slopes of the Łososina basin provided an opportunity to study the role of mass movements in landform development in mountains of medium height. The paper attempts to summarize the rate and course of slope relaxation processes using geomorphological mapping done from 1997 to 2000. The study tested the hypothesis that following the occurrence of an extreme event, slope relaxation processes will slow down mass movement processes to the point where they stop acting on the slope, and ultimately a new set of slope development processes will emerge.

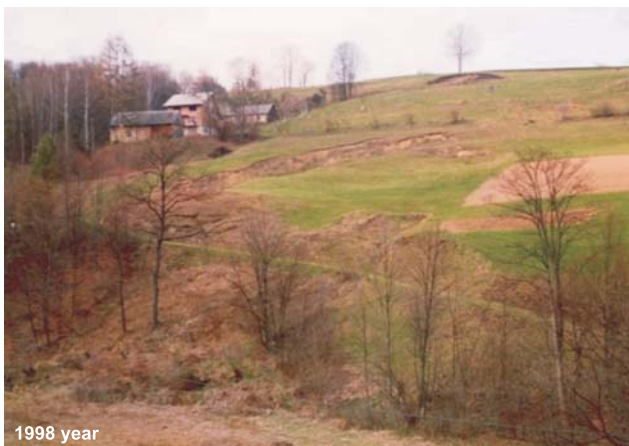
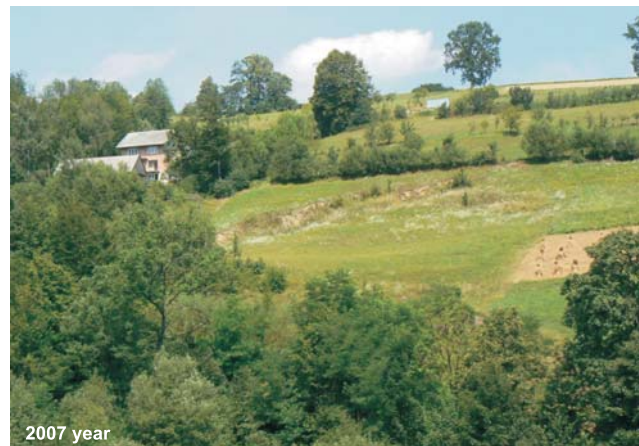
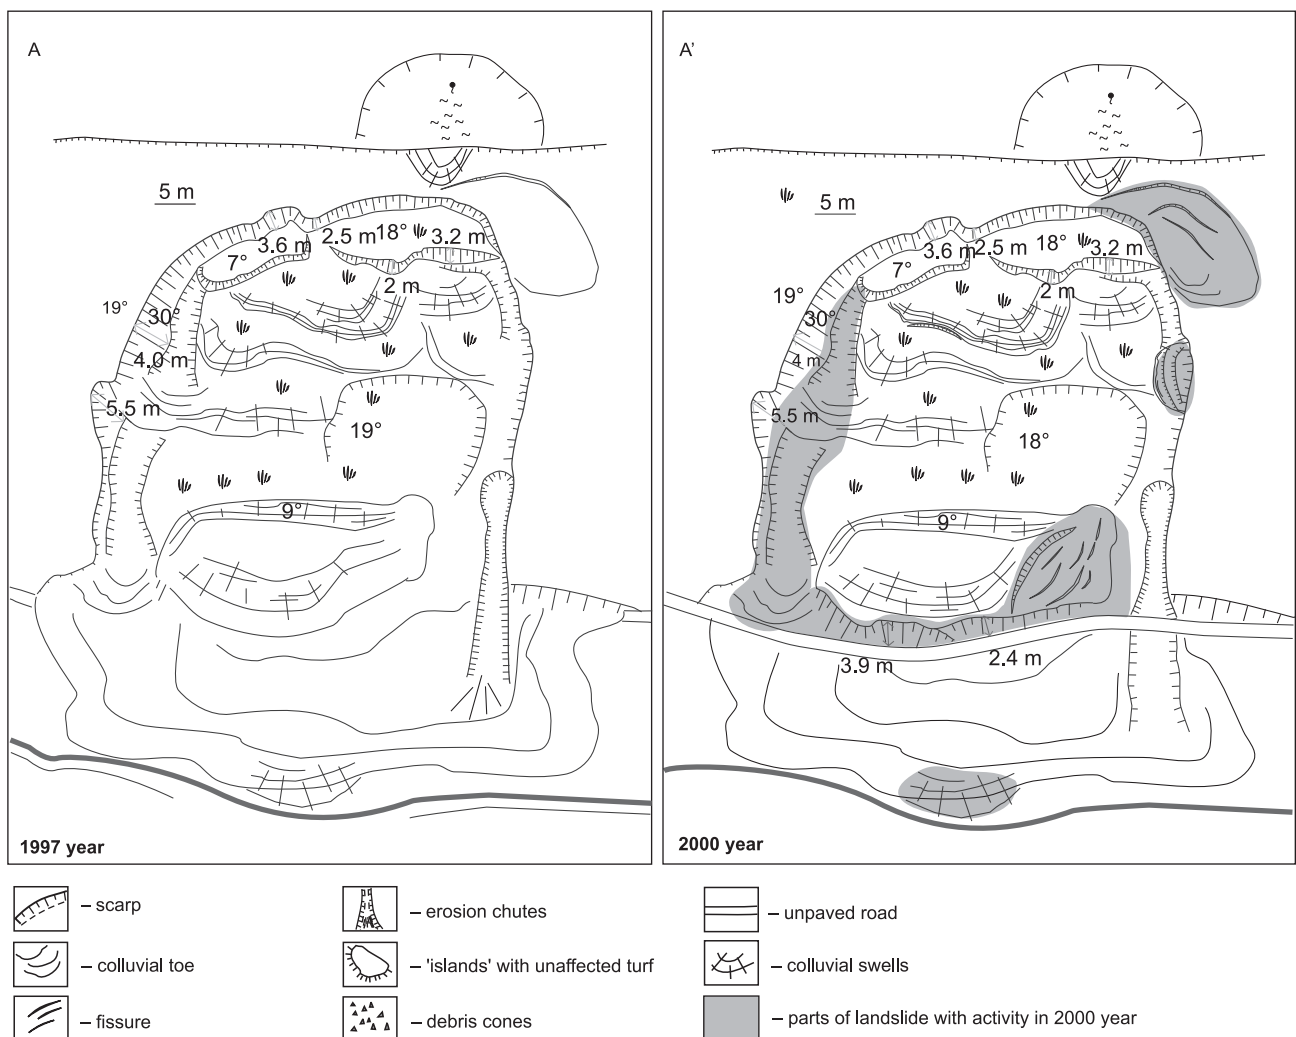
Fig. 2. A rotational slide on the slopes of the village of Mlynne (form no. 966); A – map of the slide produced in 1997 immediately after it had occurred and before human intervention; A' – map of the same slide produced in 2000

Large rotational slides, on the other hand, featured much more development (12% of forms in 2000) and accounted for the greatest share of secondary movements (16% of forms in 2000) of all the landforms studied (Fig. 2). This was largely the result of the lack of stability of the displaced colluvia, which led to their secondary displacement during the study period. The difference between the frequency of secondary mass movements of these types of landforms and the mean frequency of such movements in subsequent years was large enough that its statistical significance was at 0.05.

with a very high rate of colluvia liquefaction (Fig. 5). The effect is either a result of cutting into colluvial swells or toes or the result of removing their support during remedial action such as the rebuilding of a damaged road (Fig. 2).

Towards the end of the research project, three years after the commencement of mass movements, most of the landforms of interest were still highly visible (Fig. 2). Scar edges were still clearly visible and scars were not filled with washed-in material. No systematic surface drainage was discovered within the landforms studied despite the presence of numerous erosion dissections. Three years, however, is too short a period of time to analyze the path to full stabiliza-

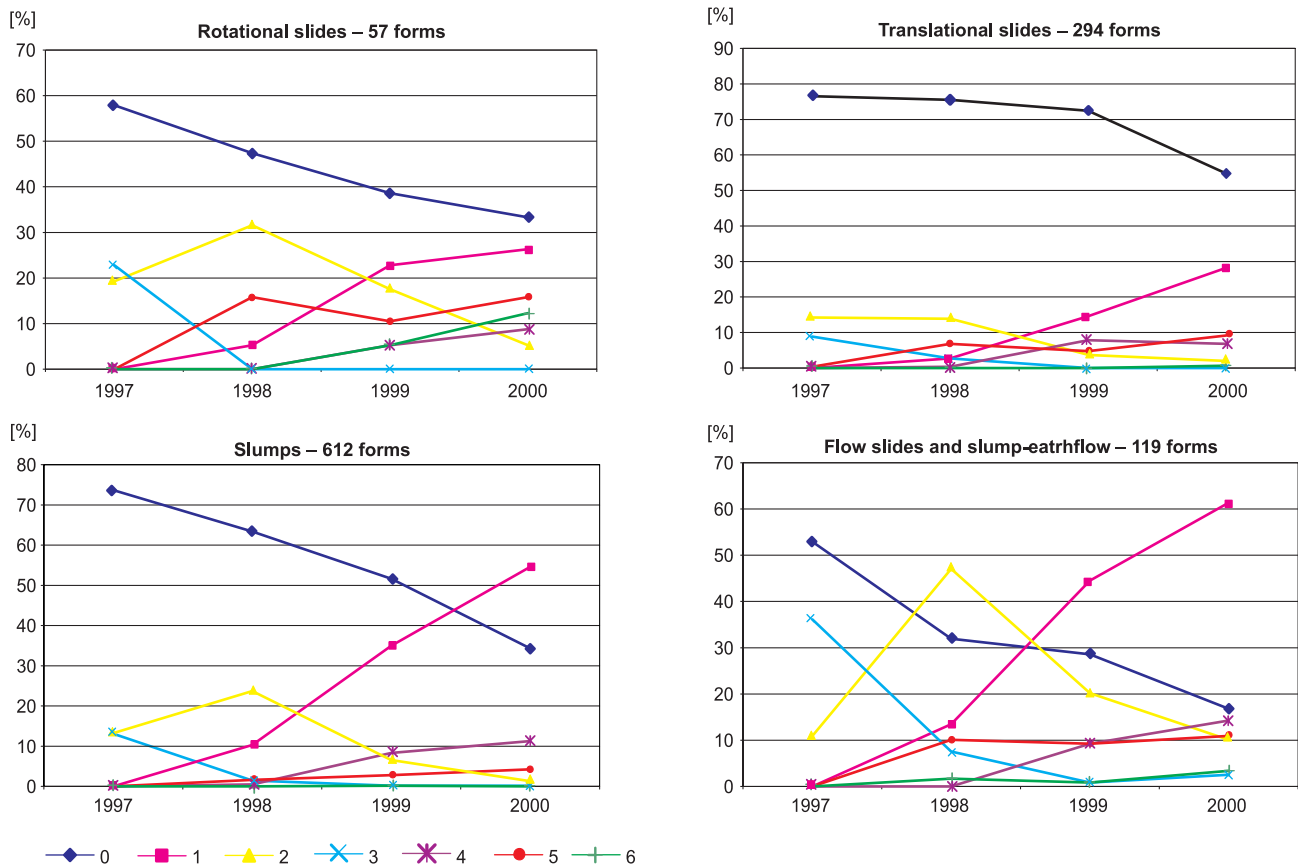
Fig. 5. Share of slope development types for the four landform types during the period 1997–2000 (“0” to “6”; see text for detailed legend)

Slides with a concave slip surface were the most numerous landform type in the study. Small rotational slides accounted for the vast majority of them at 612, while rotational slides were far less frequent at 57. The two landform types differ in terms of their predominant development types (Fig. 5).

Small rotational slides with their relatively small surface area and colluvia deposited in-situ were subject to intense degradation of scar edges (Fig. 5). The most characteristic feature of the slumps was how quickly they became overgrown with vegetation (55% in 2000). As a result of this rapid overgrowth and intense degradation of colluvial toes and scar edges, slumps were the least visible of landforms as early as four years after their initial development. Six

Translational slides (294 forms) were the most stable landform type investigated (Fig. 5). This landform type featured the largest share of forms that displayed no signs of significant change during the four-year study period (55% of forms in 2000). The difference between the percentage of unchanged translational landslides and the percentage of this type of slope development in the total number
